“Efficient Rescue Actions in Mines”

***Presented by
Malcolm D Smith***

Mosaic Esterhazy Potash Mine Fire

**Investigation into the Underground
Mine Fire
29-Jan-06**

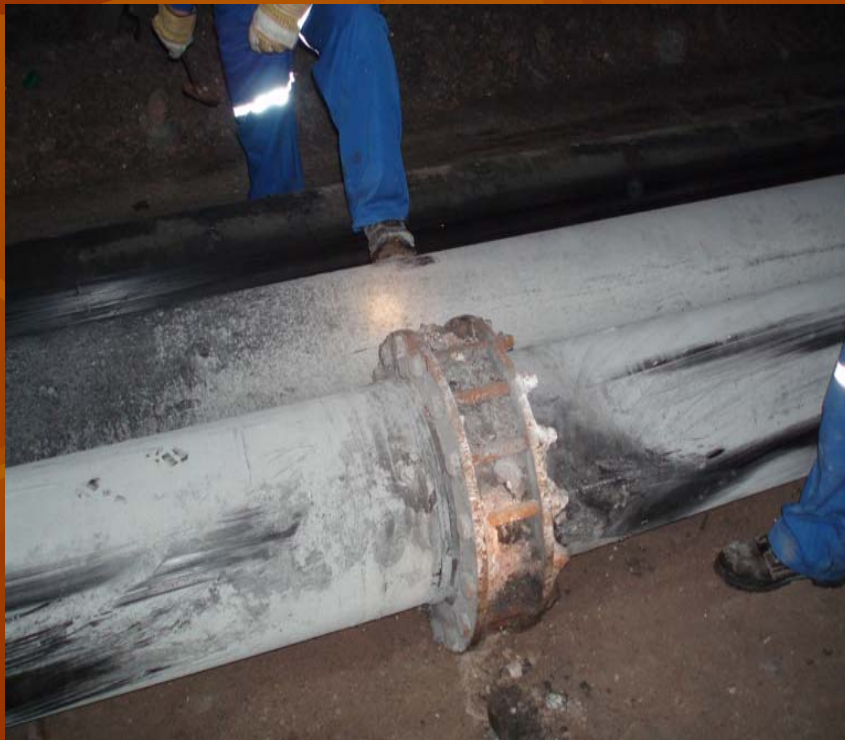
Pipe was dismantled by cutting the metal bolts from a flange connecting the pipe using a cutting torch. Cutting of the bolts around the pipe joints allowed high-temperature open flame from the torch to impinge on the interior of the pipe joints.

*Fire inside the pipe
was not detected as the
products of
combustion were
pushed down the open
ended pipe by the large
airflow of 130,000
cubic feet per minute
in the main entry
#000400*

The lives of 72 mineworkers were put at risk because hot work procedures were not followed by the workers involved that resulted in the ignition of the pipe.

The main ingredient in the manufacturing of this pipe is polyethylene copolymer (>99%), which is a petroleum-based product. When the pipes burned, a large amount of heavy black carbon soot was released into the mine air, which reduced visibility to almost zero.

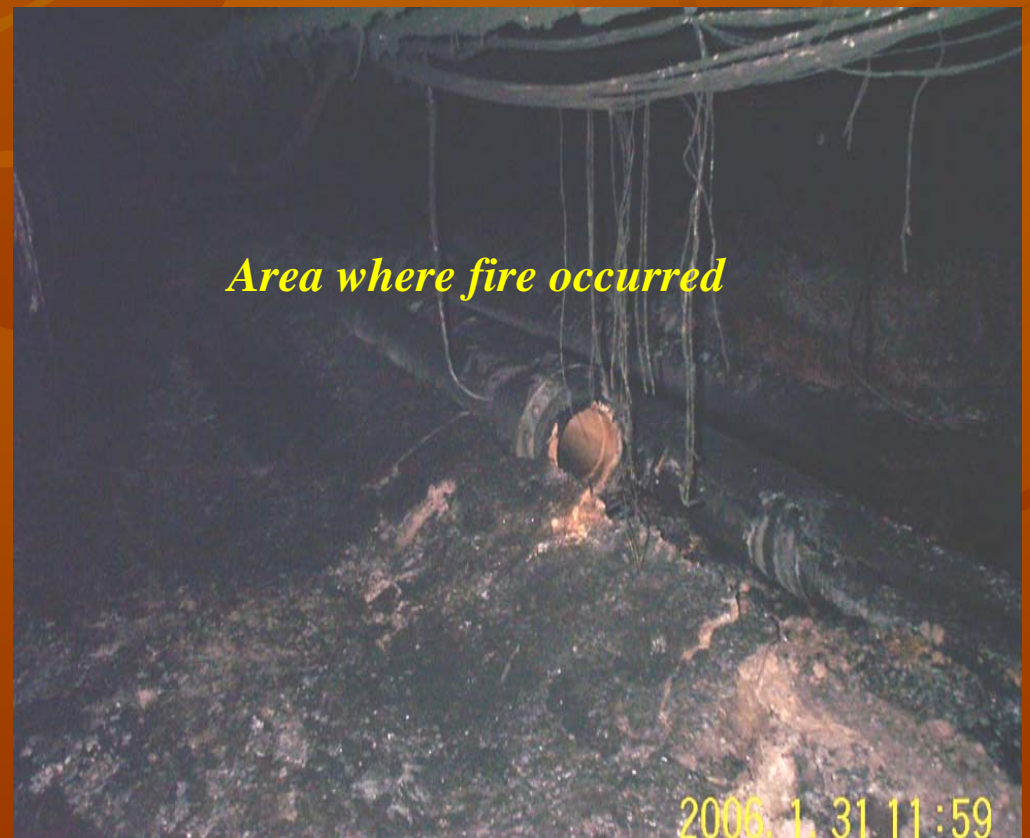
*Early Sunday morning, January 29, 2006
this fire at the Mosaic K2 underground mine
caused 72 mine workers to retreat to refuge
stations throughout the mine and prompted
the mines rescue intervention.*

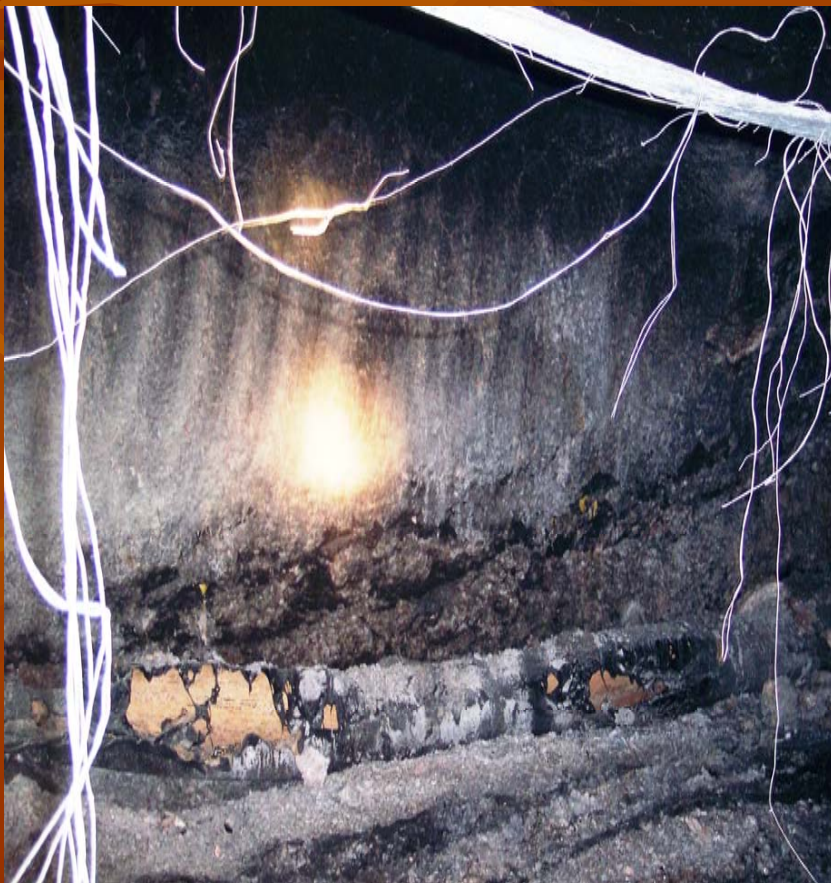
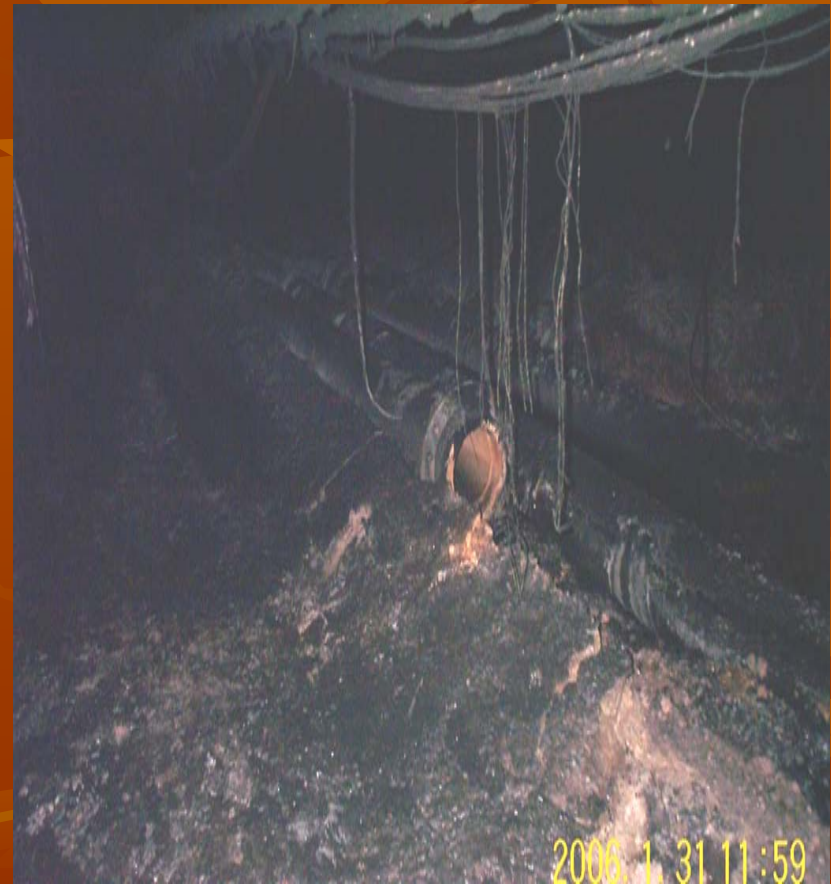
During the January 29, 2006 underground fire in the K-2 side of the combined K-1, K-2 mining complex, 72 workers took refuge in 8 locations.

The # 000650 refuge station was totally isolated some 646 meters west from the fire location.

There was no electricity or phone communications to this refuge station for the duration of the incident

There is one entrance to this refuge station and has a total volume of 1203.5 cubic meters

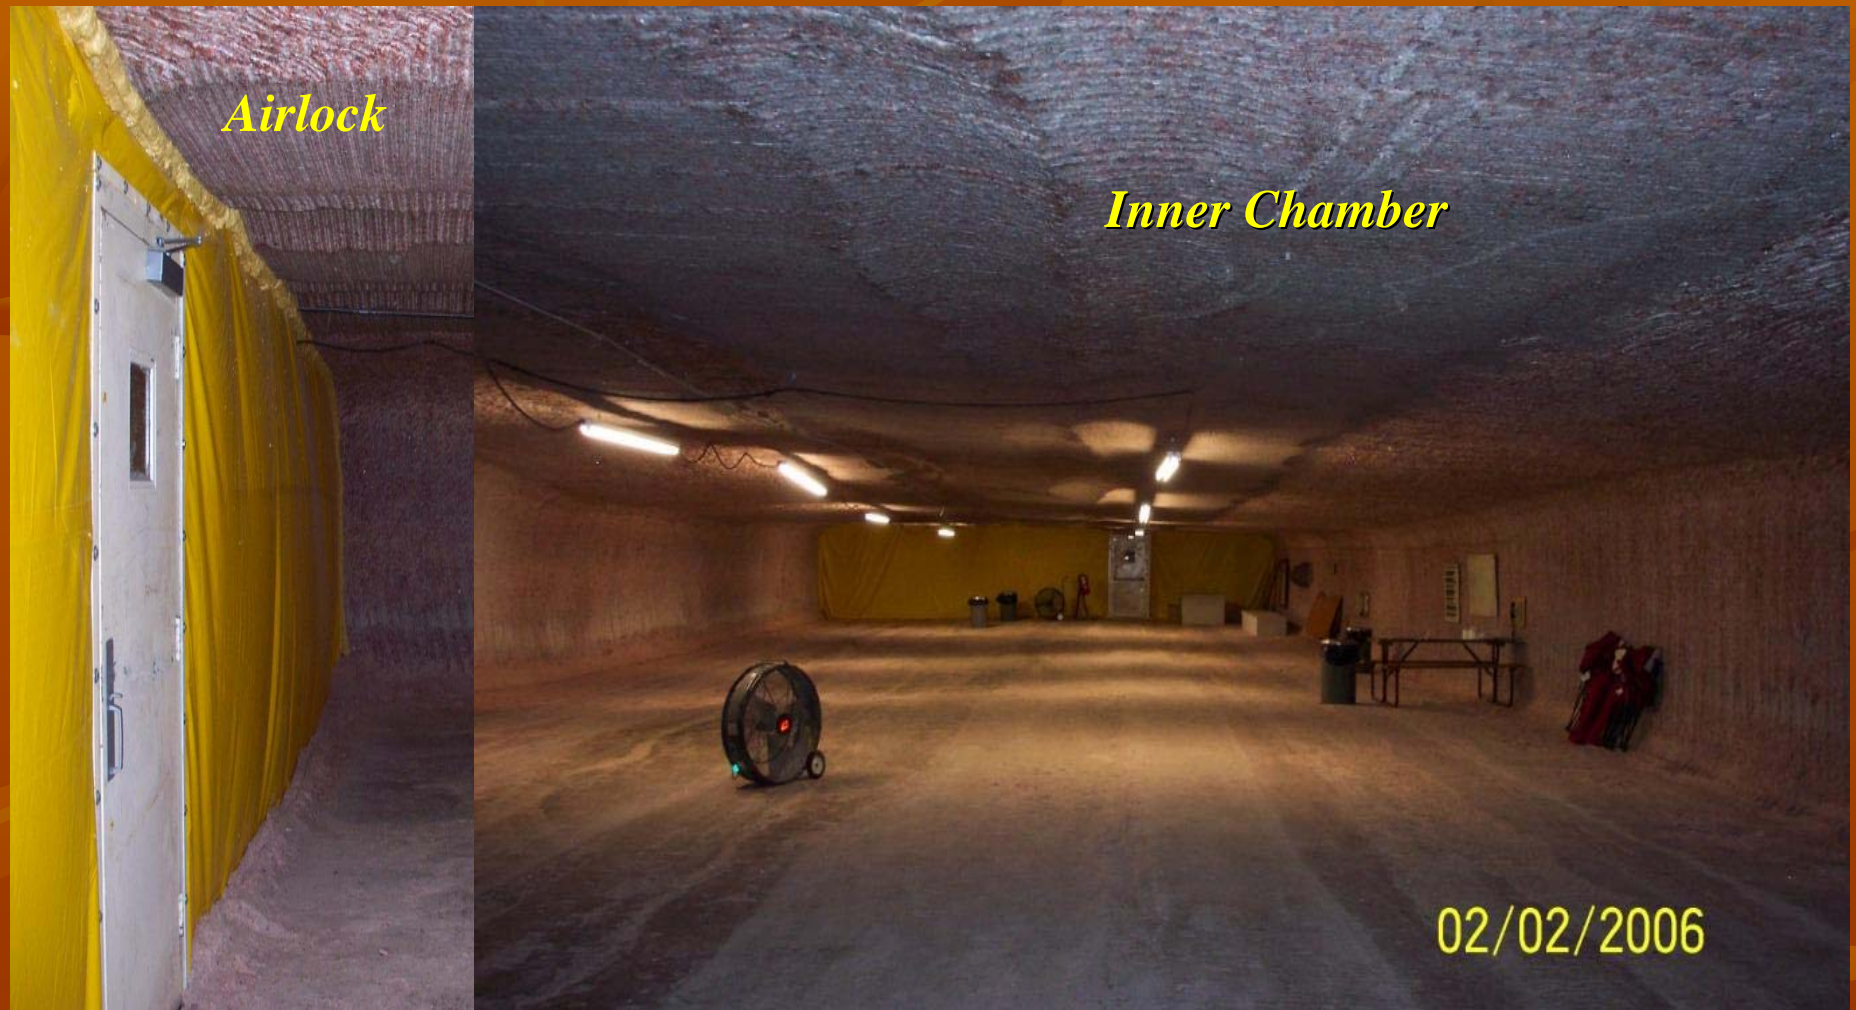
#000650 REFUGE STATION

REFUGE STATION INFORMATION

SIZE: 1203.5 m³

OF WORKERS: 32

TIME SPENT REFUGED: 24 HRS

SUPPLIES

- **PHONES: 1**
- **FEMCO PHONES: 1**
- **WATER: 6 - 20 LITER JUGS**
- **TOILETS: 2**
- **OXYGEN: 2**

SUPPLY BOX

- **CAULKING**
- **FOAM**
- **BLANKETS**
- **FOOD**
- **FIRST AID BOX**
- **SPAD GUN**
- **SPADS**
- **BRATTICE**

Electric fans could not be used. Heat and humidity was a concern for the workers most found that they felt cooler when lying on the floor and did so.

Toilet facilities were quickly filled to overflowing and the workers found it necessary to empty a large water bottle into their personal water containers and use it to urinate into.

Workers reported the auxiliary refuge station was adequate but would like to see electrical power for lights and fans. Extended periods in the dark was a concern.

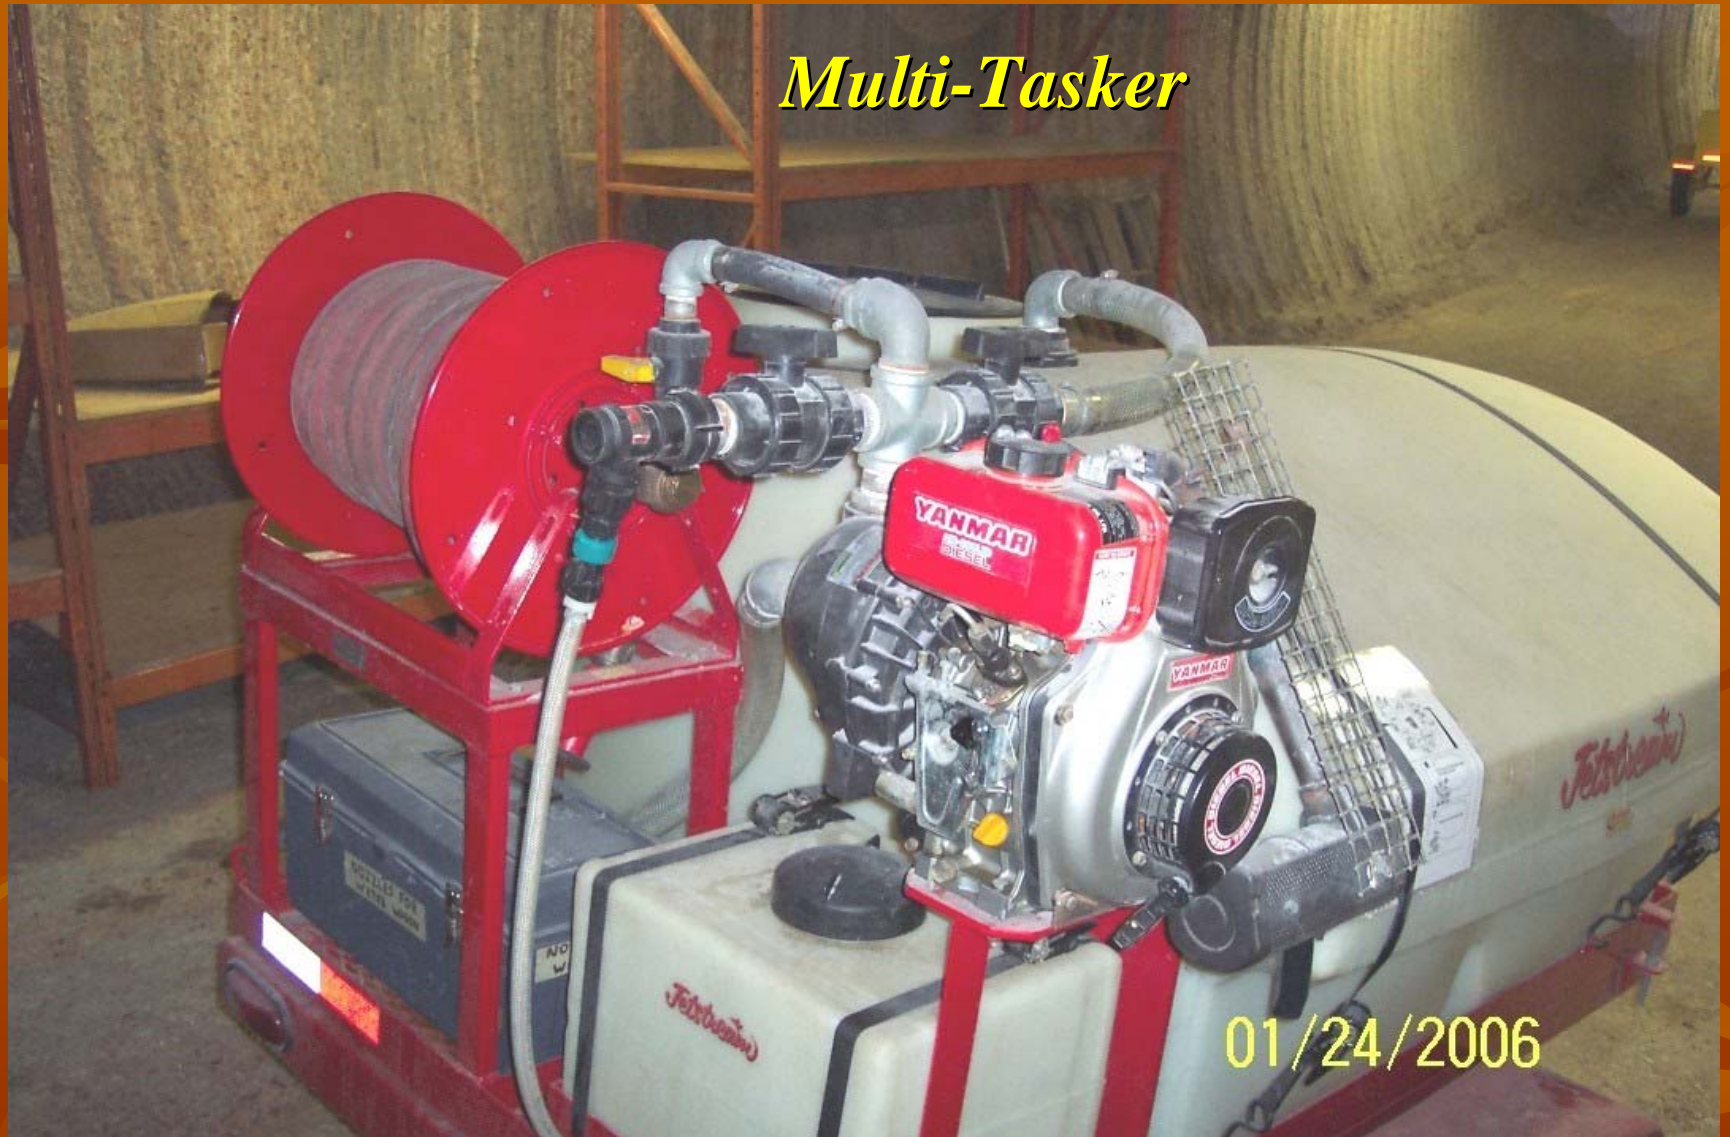
*Proceeded to fire area
distance 2.5 kilometers
Extinguish the fire
using the Multi-Tasker
Continue to the Inflow
area*
